REPAIRS TO BELLCOTE

EUXTON PARISH CHURCH—REPAIRS

Progress Photographs dated 21st October 2021

58040/I

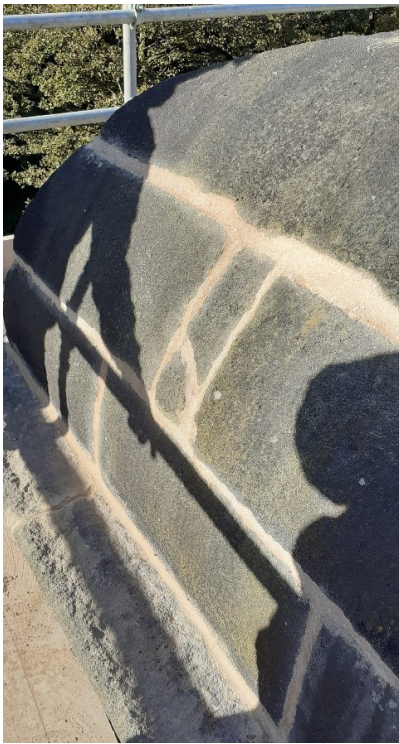
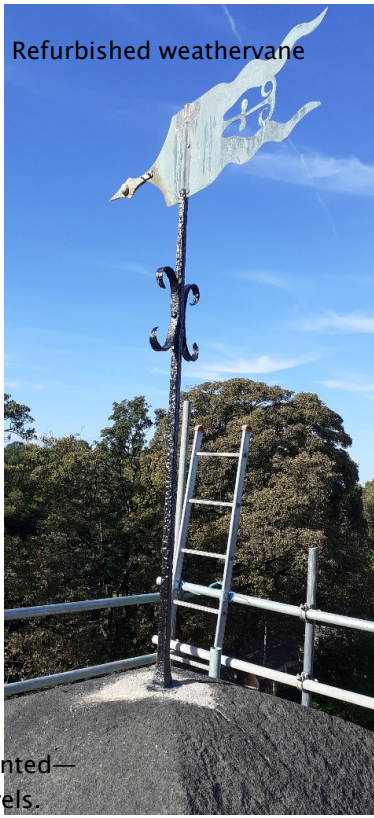
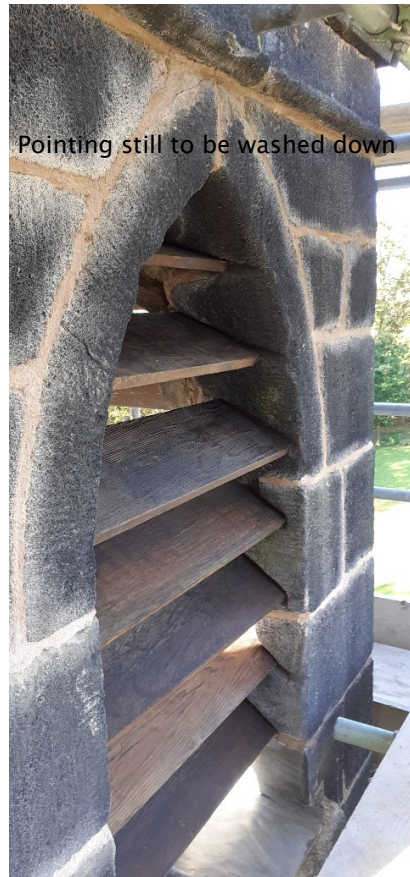
Existing louvres oiled and reinstated

Top of bellcote repaired and repointed—repointing proceeding at lower levels.

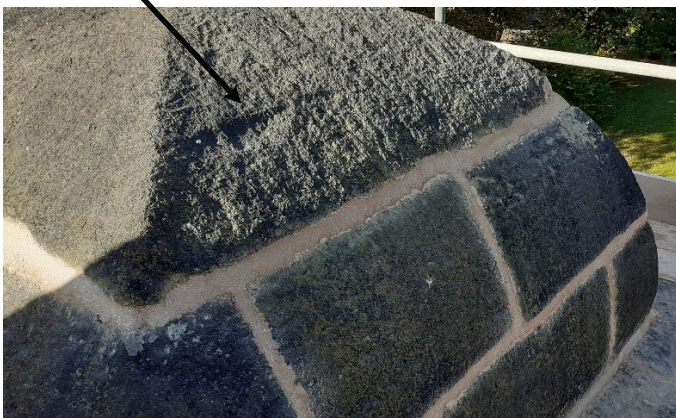
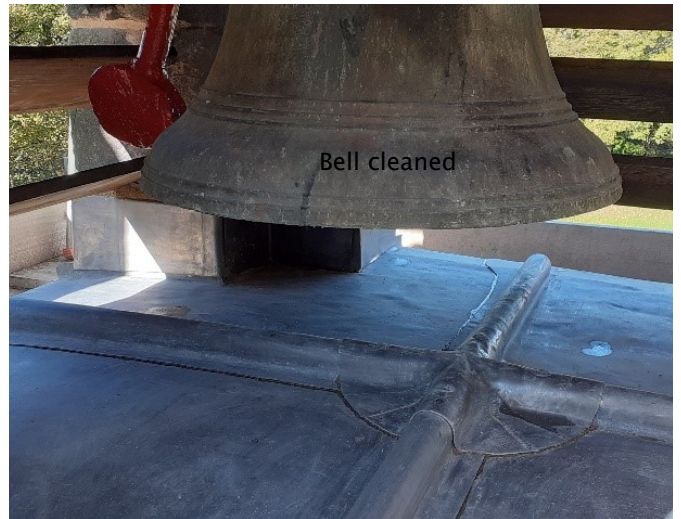
Bell frame / metalwork treated and painted to match existing

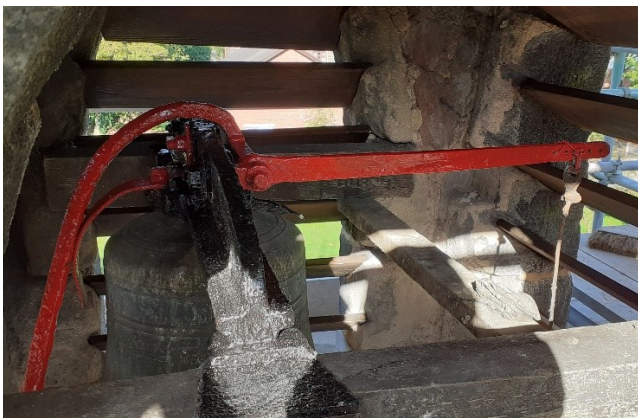
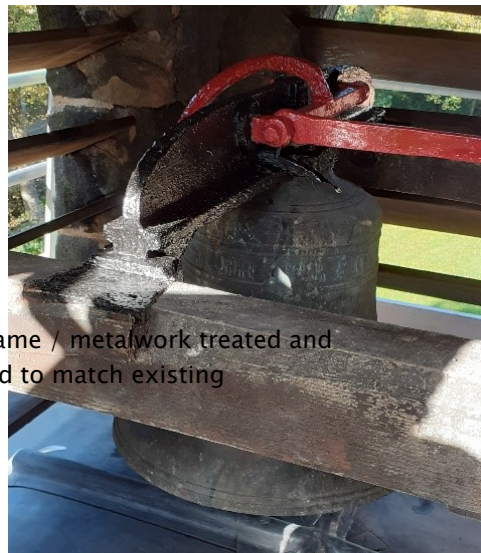
Bell frame / metalwork treated and painted to match existing

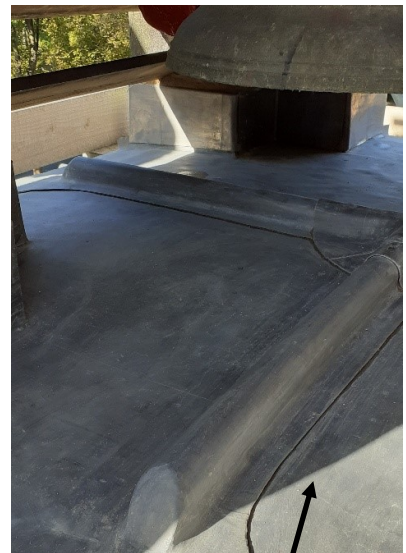
Base of bell chamber—void filled with masonry, screeded and new lead covering installed (all rotten timber scrapped)

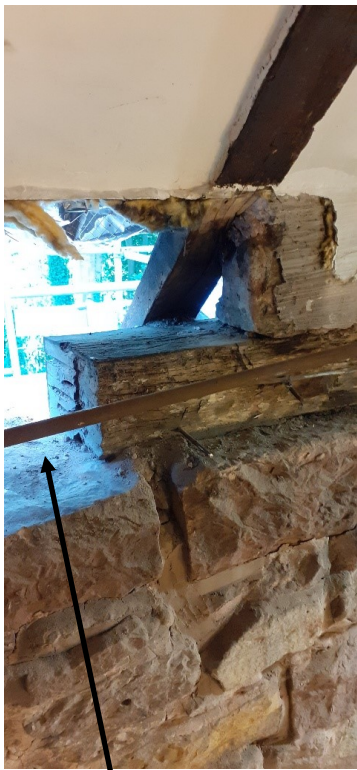
Missing inner wall plate (previous rot?)

Rotten timbers—south east
end of nave

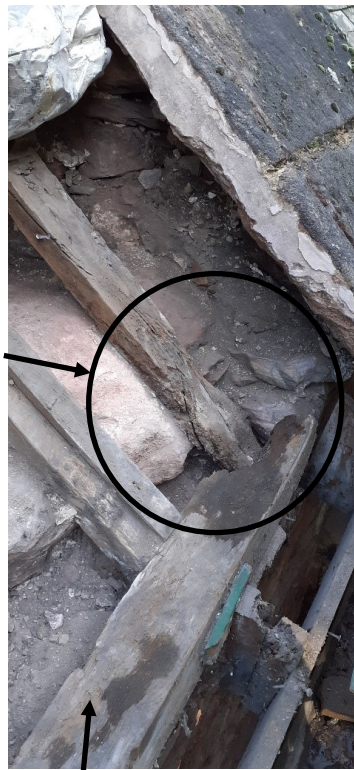
Outer wall plate

East nave copings

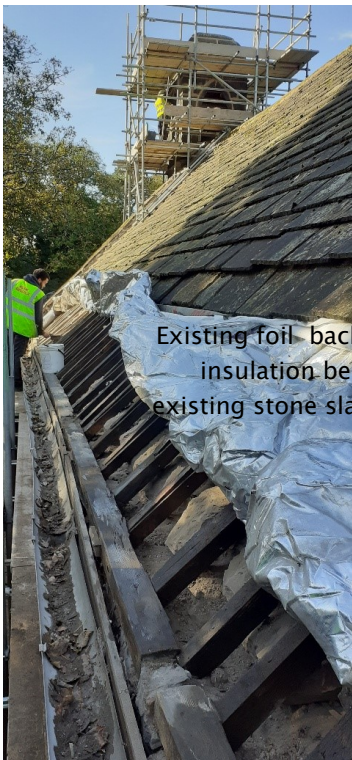
Existing foil backed
insulation below
existing stone slates

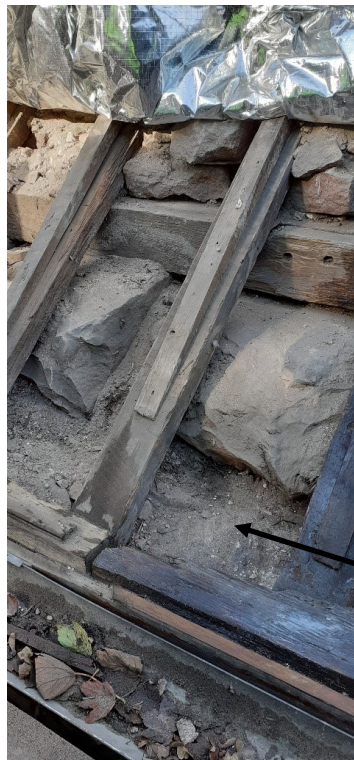
Wall head cleared of
rubble infill

Timber treatment

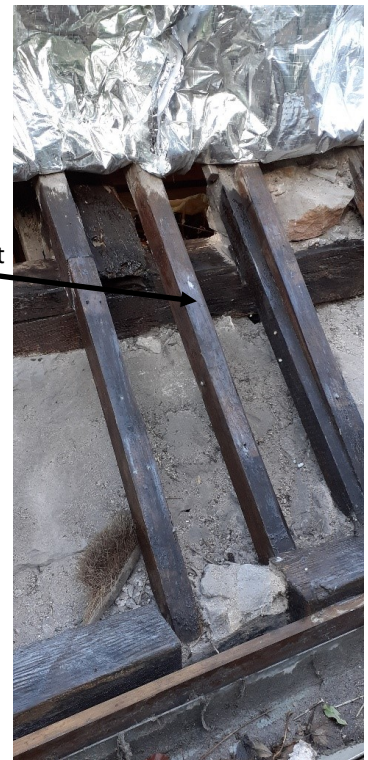
Investigations and treatment of south nave eaves timbers—proceeding

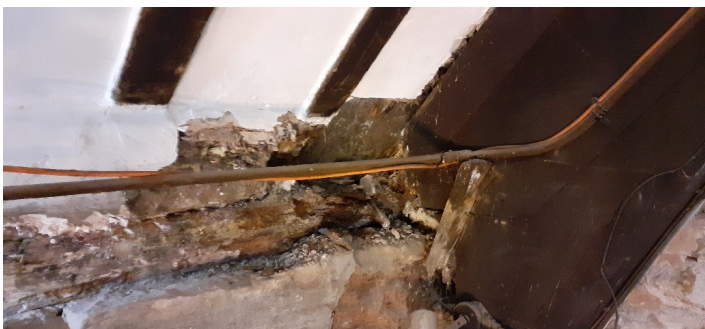
Rotten eaves timbers—north east corner of nave

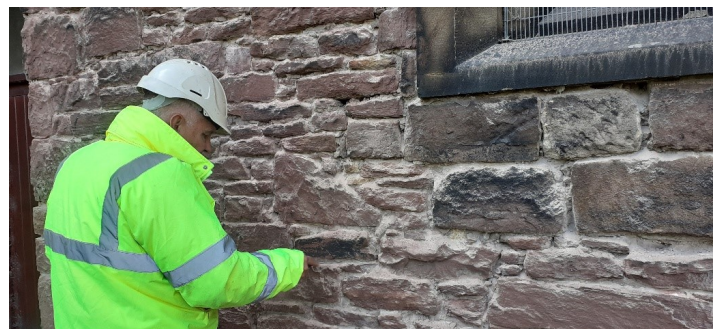
Raking out cement mortar—east wall
