EUXTON PARISH CHURCH—REPAIRS

Progress Photographs dated 9th December 2021

58040/N

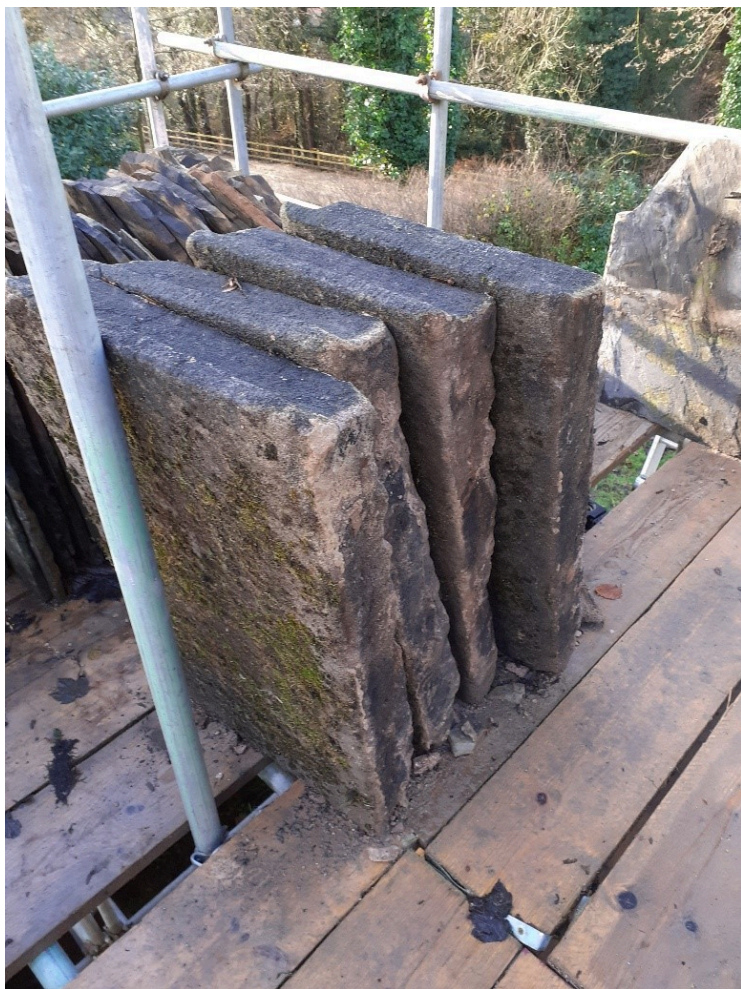
Coping stones dismantled prior to reinstatement

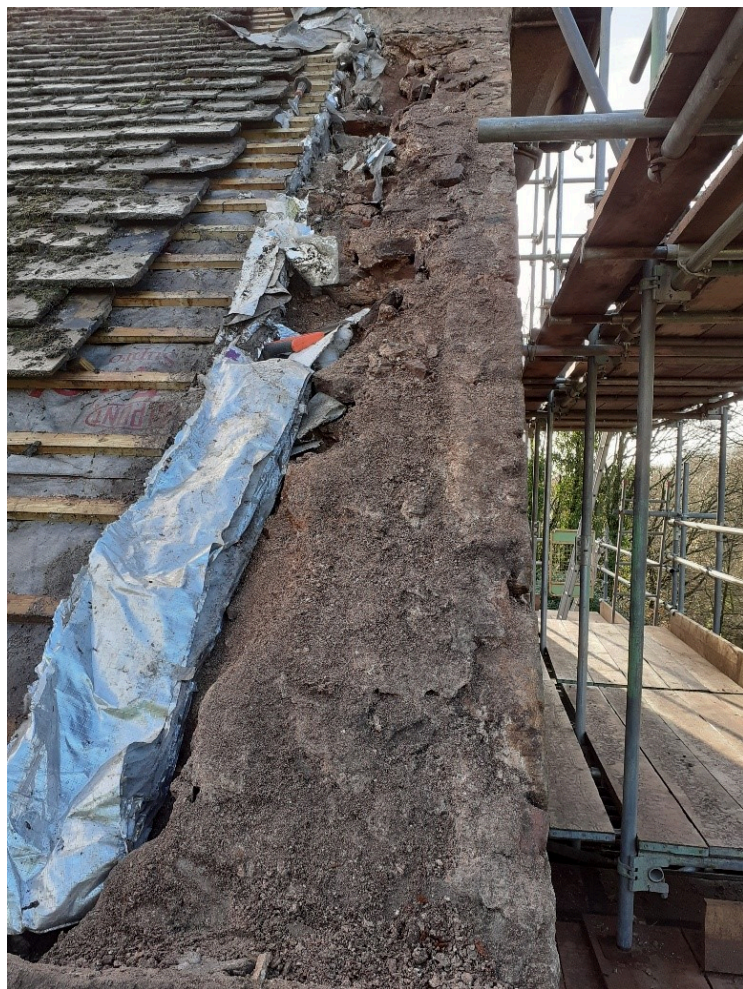
North west copings dismantled

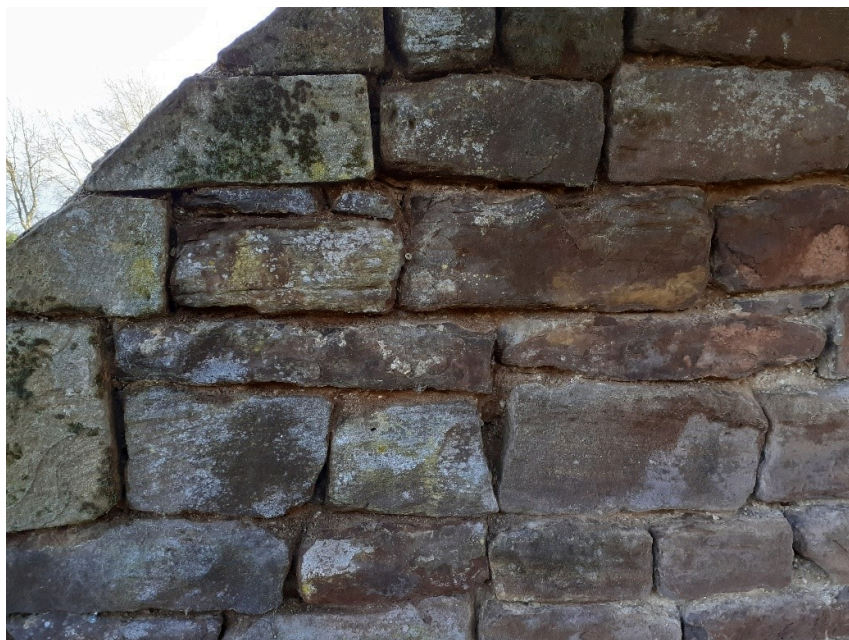
Raking out—west gable—prior to repointing

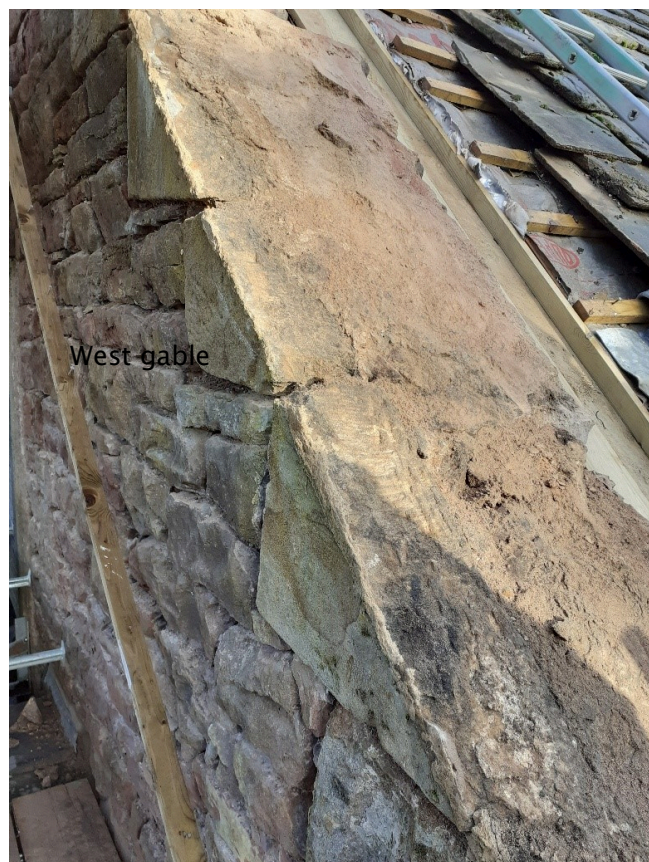
South west copings dismantled

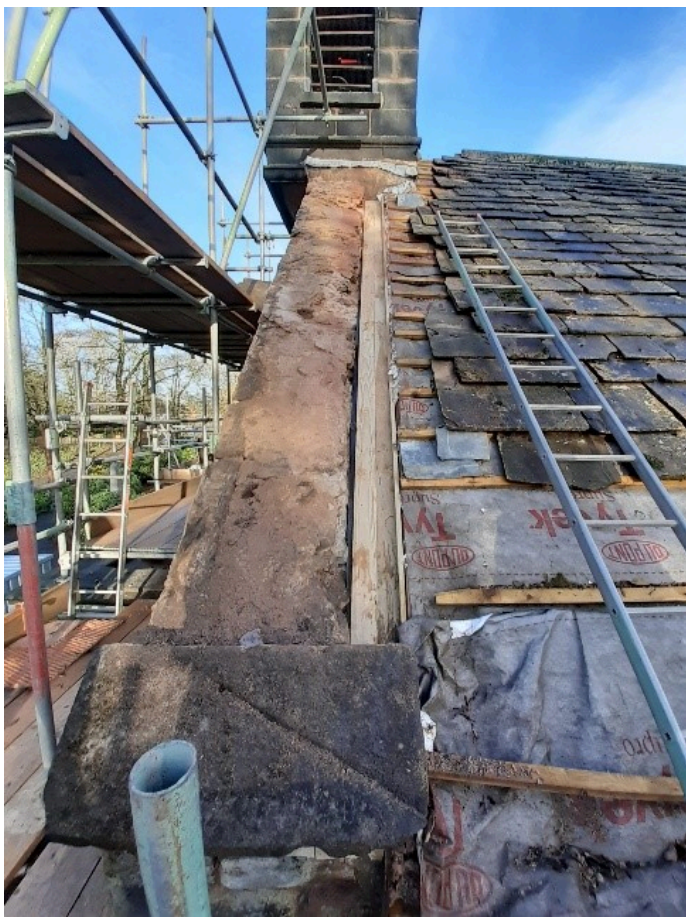
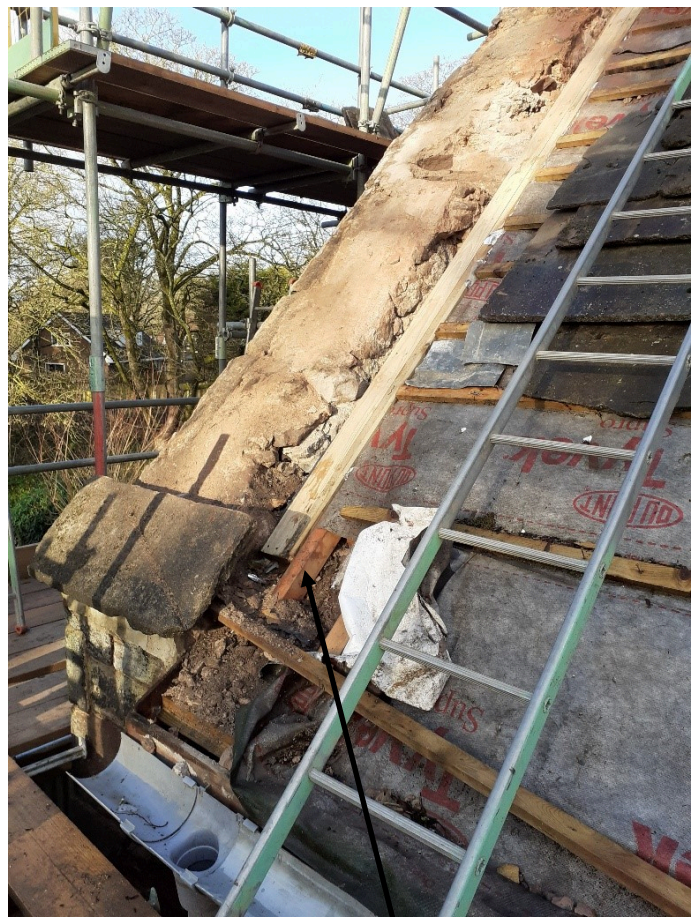
Position of last rafter

Construction of new secret gutter—at west end of south nave

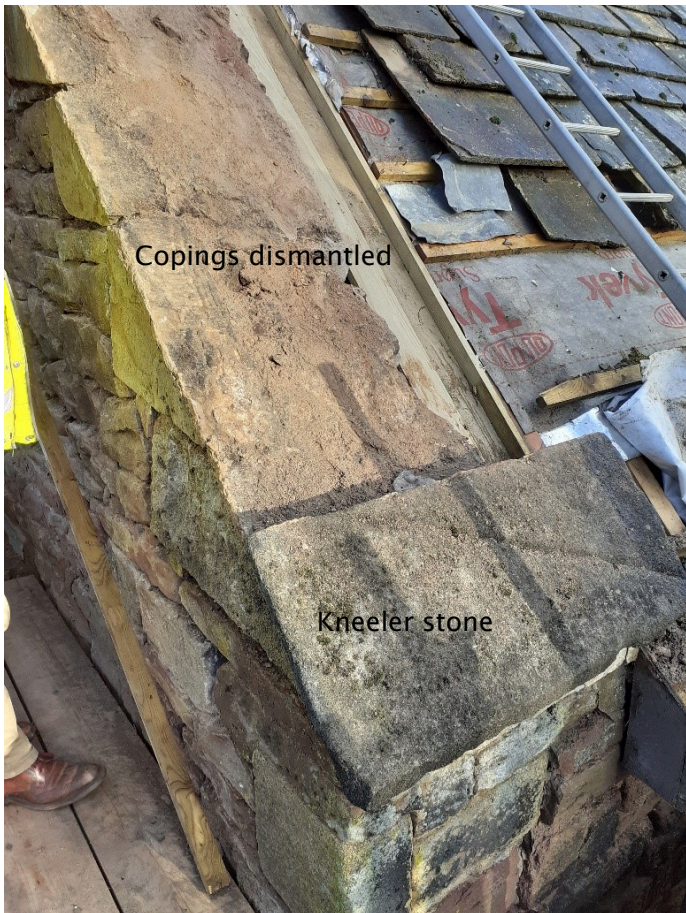
Secret gutter set out in relation to last rafter position
(to gain maximum depth / upstand against copings)

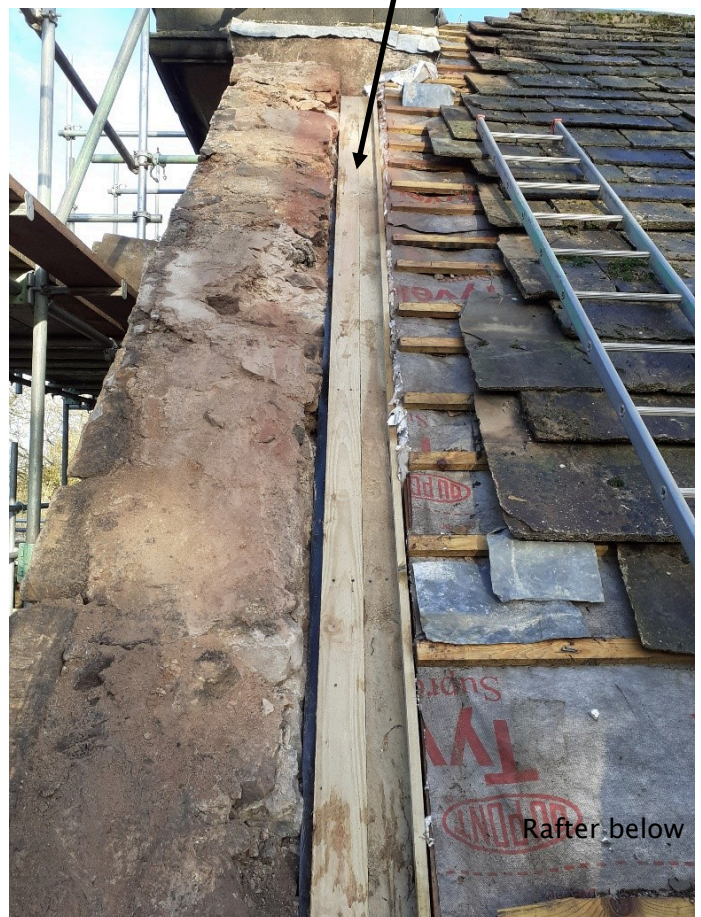
Rafter below
